## Decay - Root Canal (Direct Post & Core)

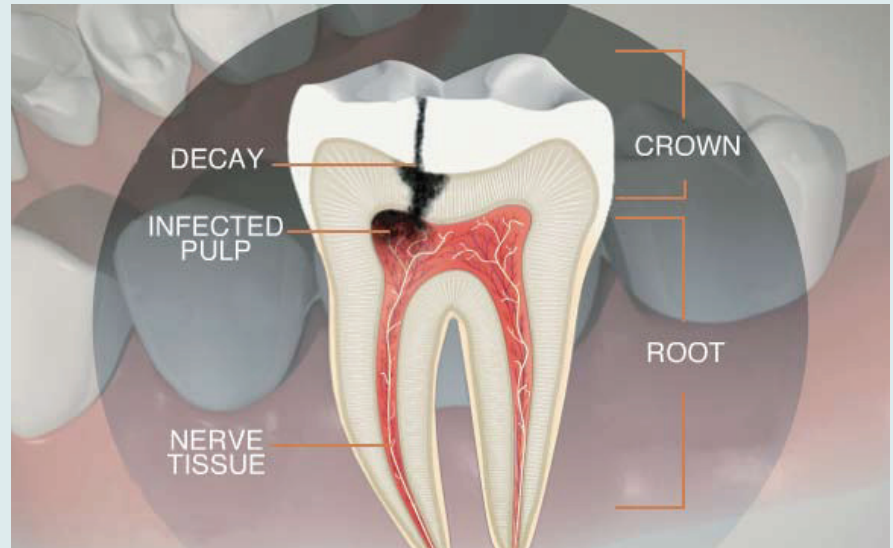
You can see from this crosssectional view that decay has penetrated to the pulp of the tooth. When a tooth is significantly decayed, meaning the pulp is damaged, a root canal is required. The steps below demonstrate the direct post and core restoration used in conjunction with a crown restoration.

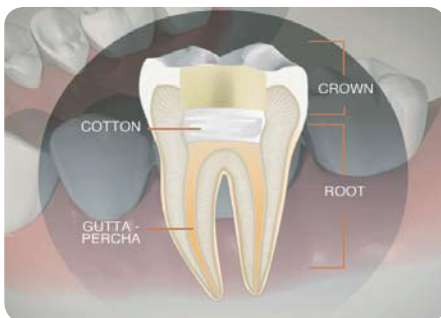
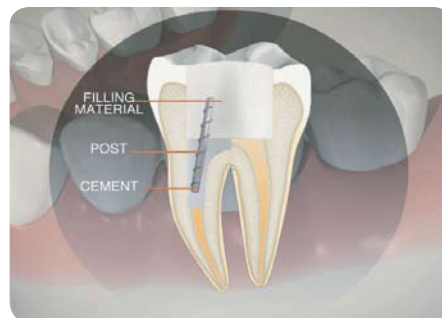
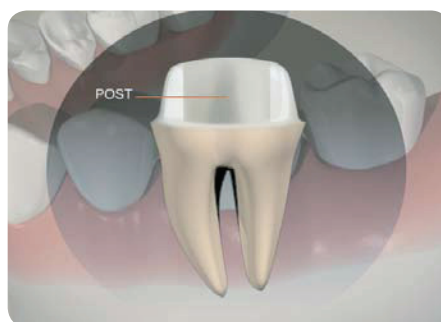
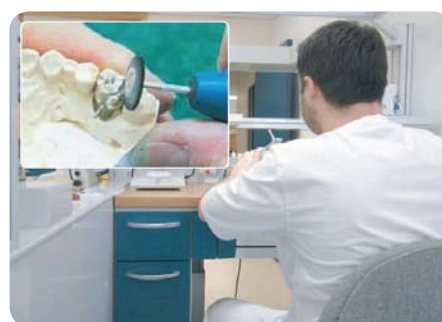
Gutta-Percha replaces the pulp to keep the tooth strong. The direct post is then cemented in place and the tooth is prepared for the crown. A temporary crown may be used while the final crown is custom made at the dental lab.

Once the final crown is finished, the temporary crown is removed and the final crown is cemented in place.
