Decay - Root Canal (Indirect Post & Core)

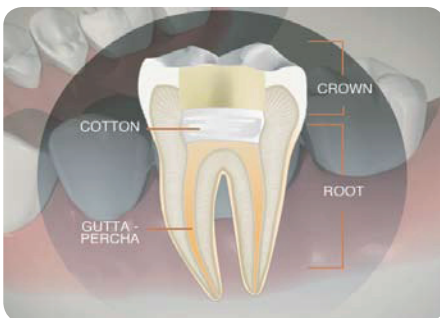
Gutta-Percha replaces the pulp to keep the tooth strong. The tooth is then prepared for the post. The custom post is made at the dental lab.

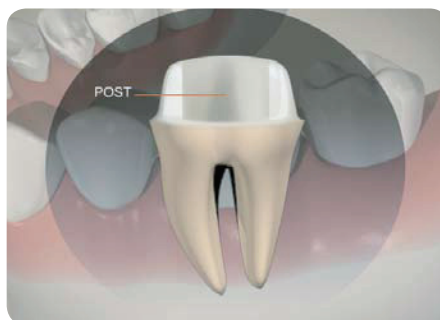
Once finished, the post is then cemented in place and the tooth is prepared for the crown. A temporary crown may be used while the final crown is custom made at the dental lab.

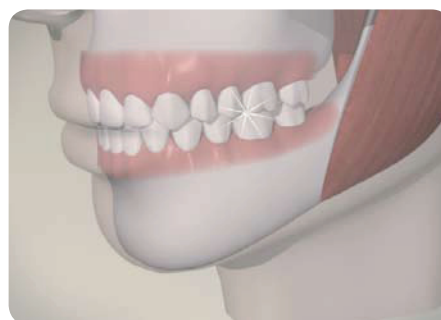
Once the final crown is finished, the temporary crown is removed and the final crown is cemented in place.
